DIVISION 7 TRAINING AND SAFETY NEWSLETTER

August 2016

38TH ANNIVERSARY OF "WALDBAUM'S"

"Waldbaum's."

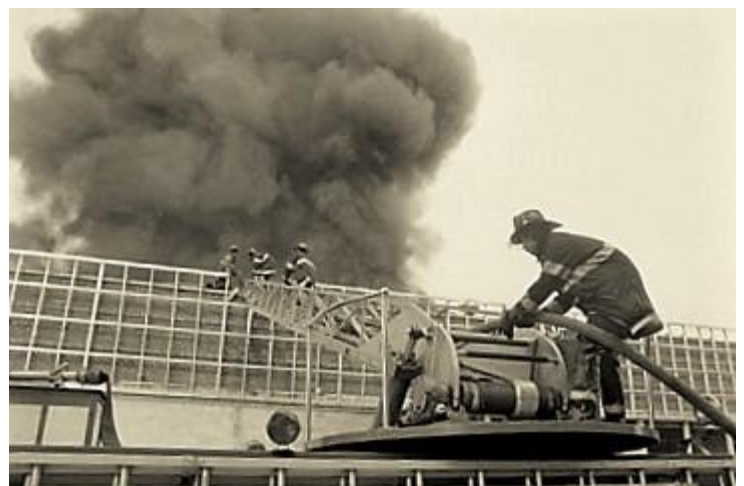
Engine 246 stretched a 2 ½ inch hand line to roof up Ladder 156 on Ocean Avenue, Exposure 1

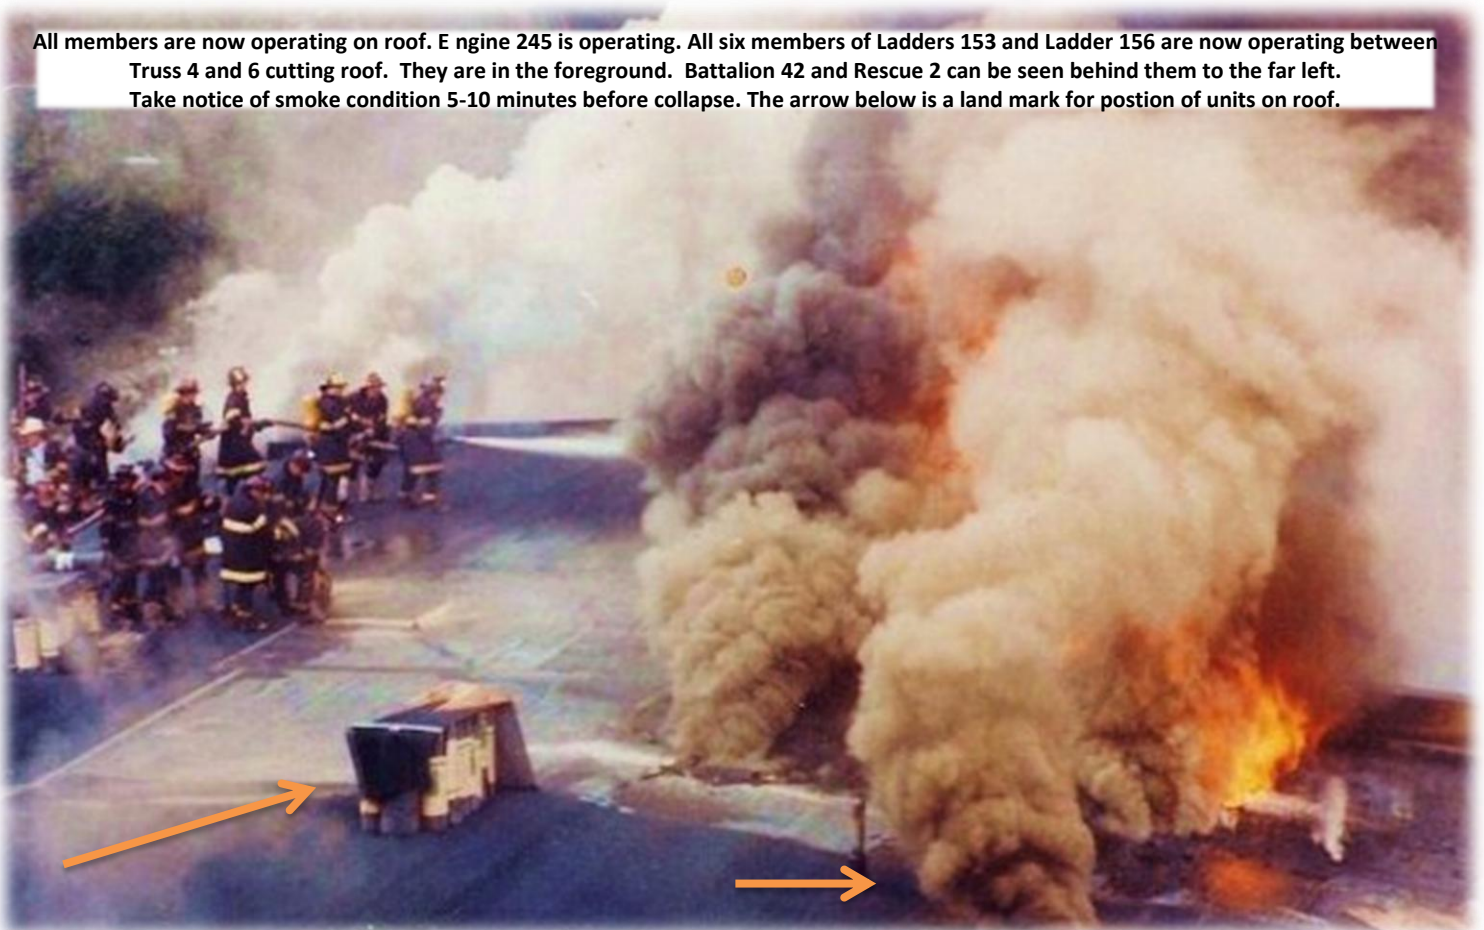
All members are now operating on roof. Engine 245 is operating. All six members of Ladders 153 and Ladder 156 are now operating between Truss 4 and 6 cutting roof. They are in the foreground. Battalion 42 and Rescue 2 can be seen behind them to the far left. Take notice of smoke condition 5-10 minutes before collapse. The arrow below is a land mark for position of units on roof.

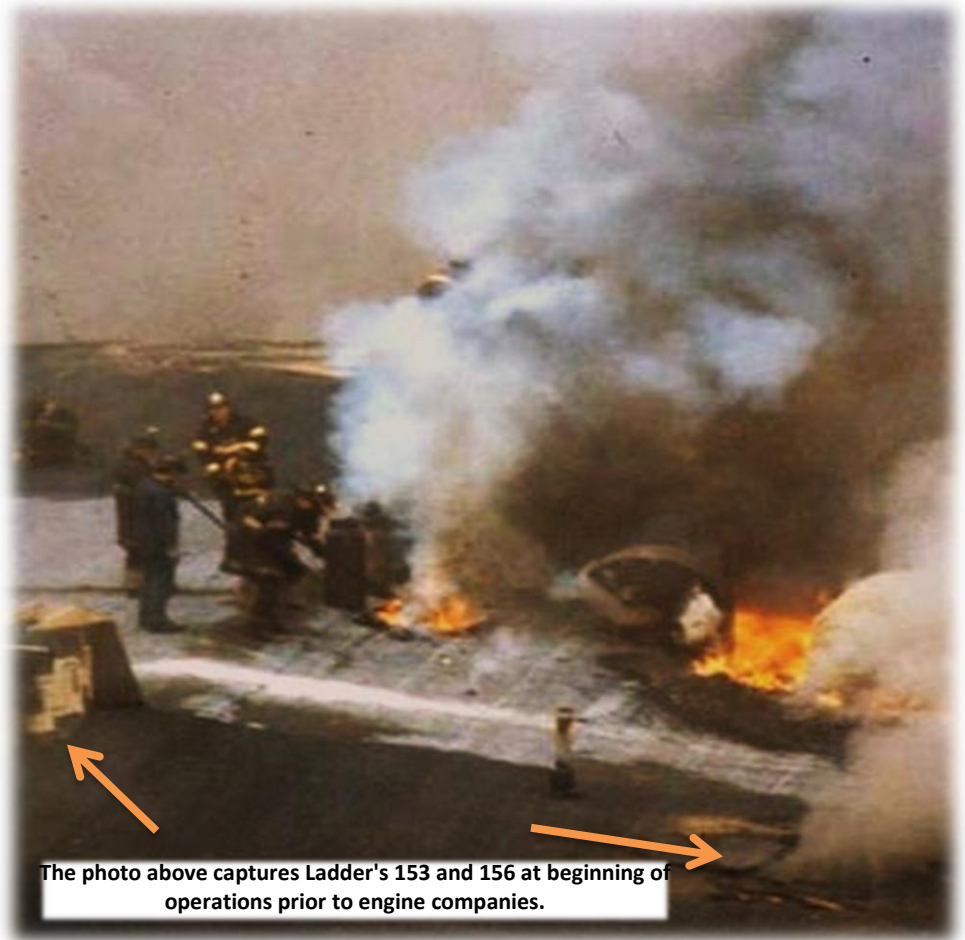
The photo above captures Ladder's 153 and 156 at beginning of operations prior to engine companies.

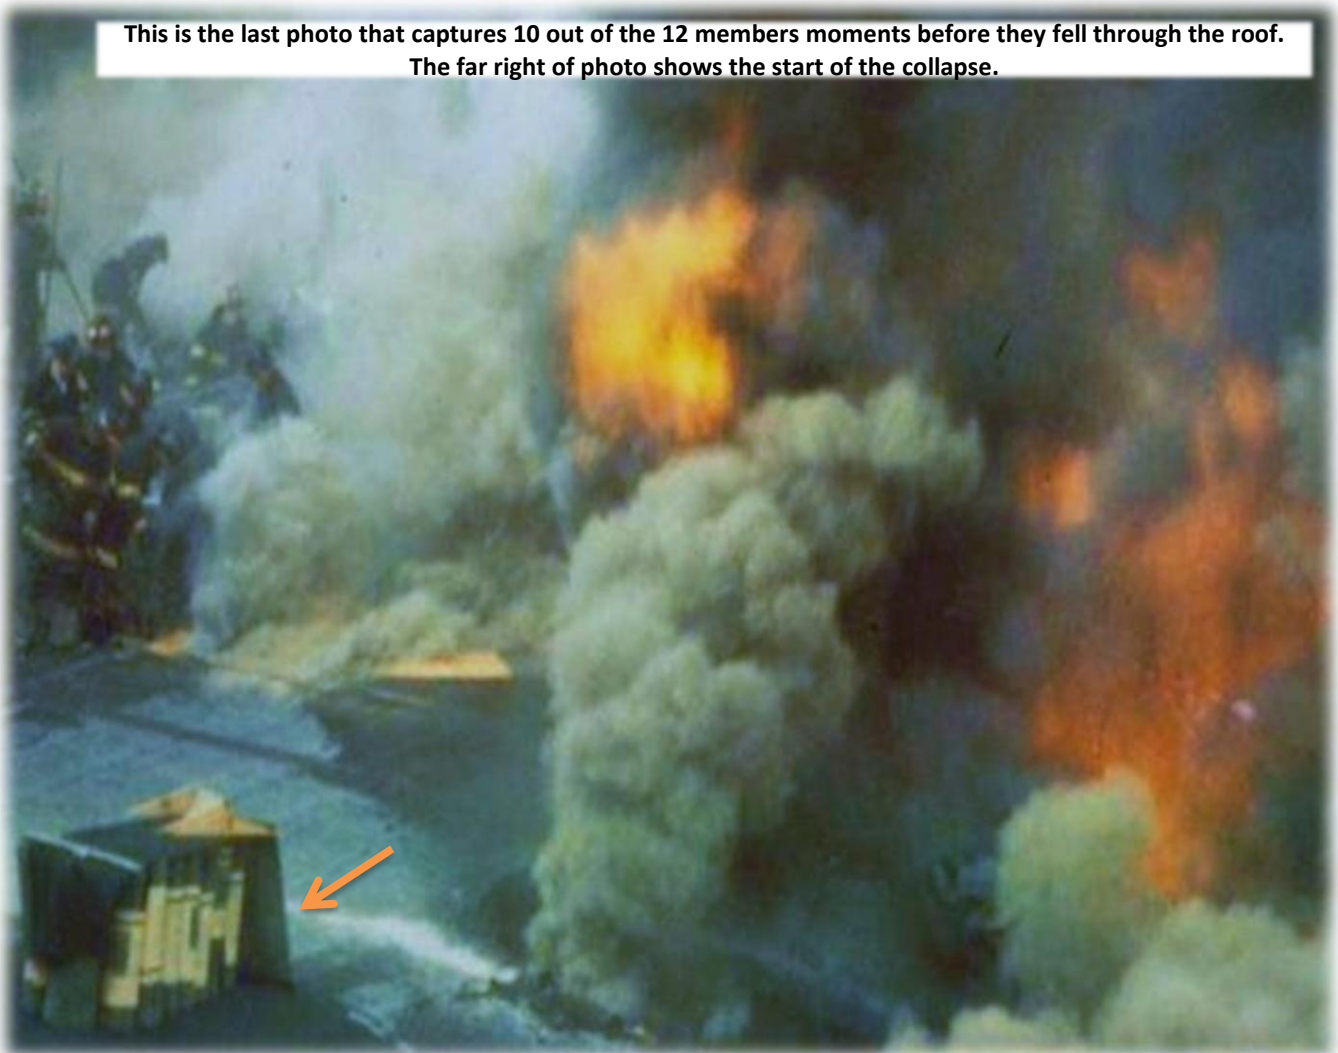
This is the last photo that captures 10 out of the 12 members moments before they fell through the roof. The far right of photo shows the start of the collapse.

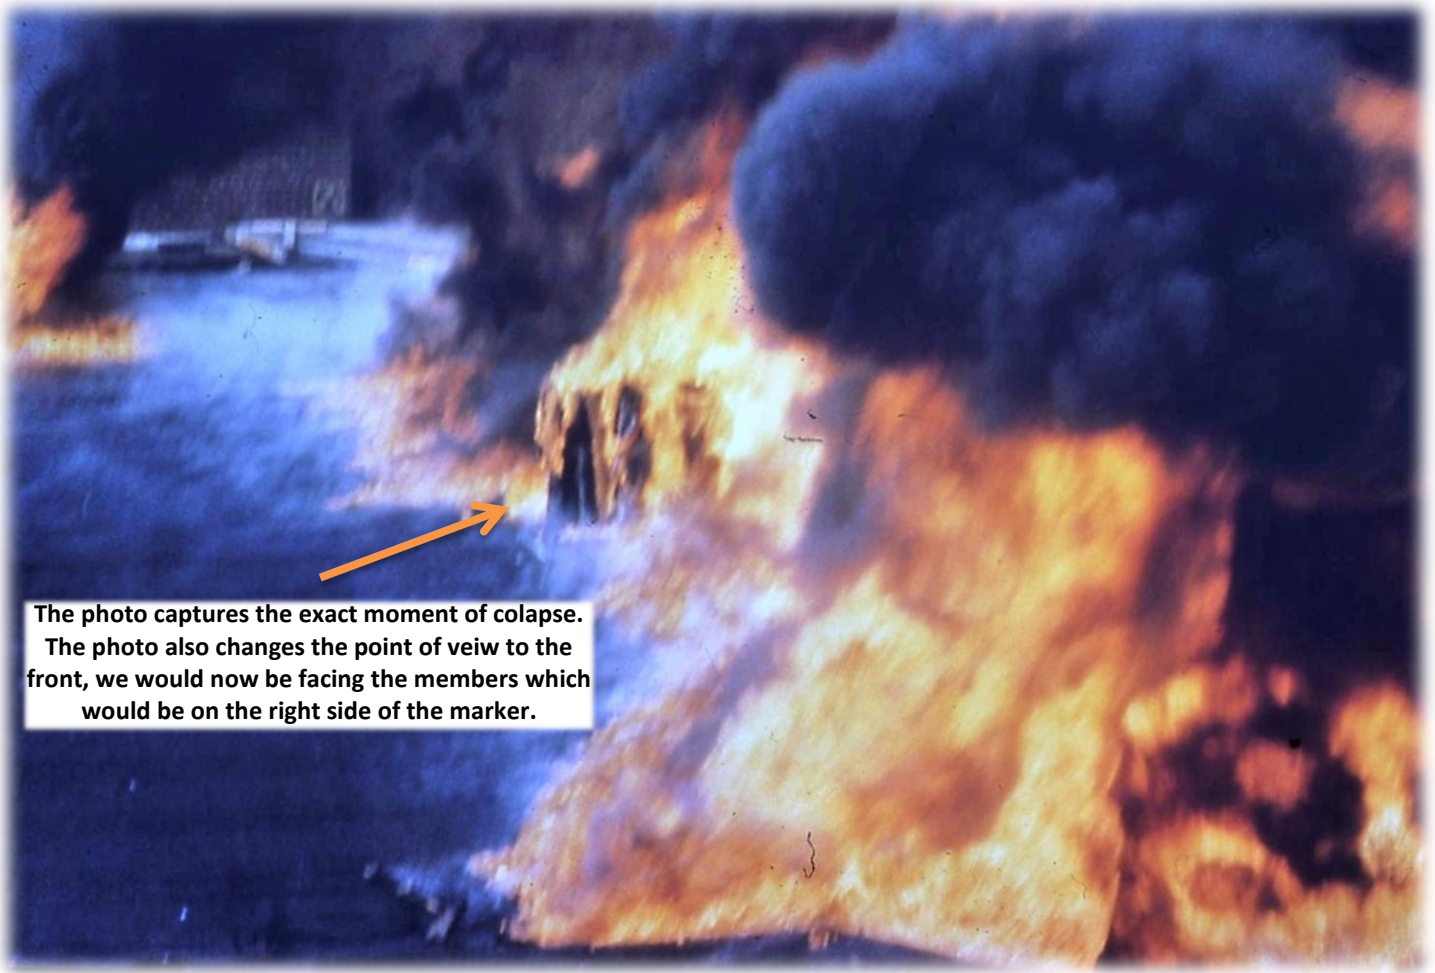
The photo captures the exact moment of collapse. The photo also changes the point of view to the front, we would now be facing the members which would be on the right side of the marker.

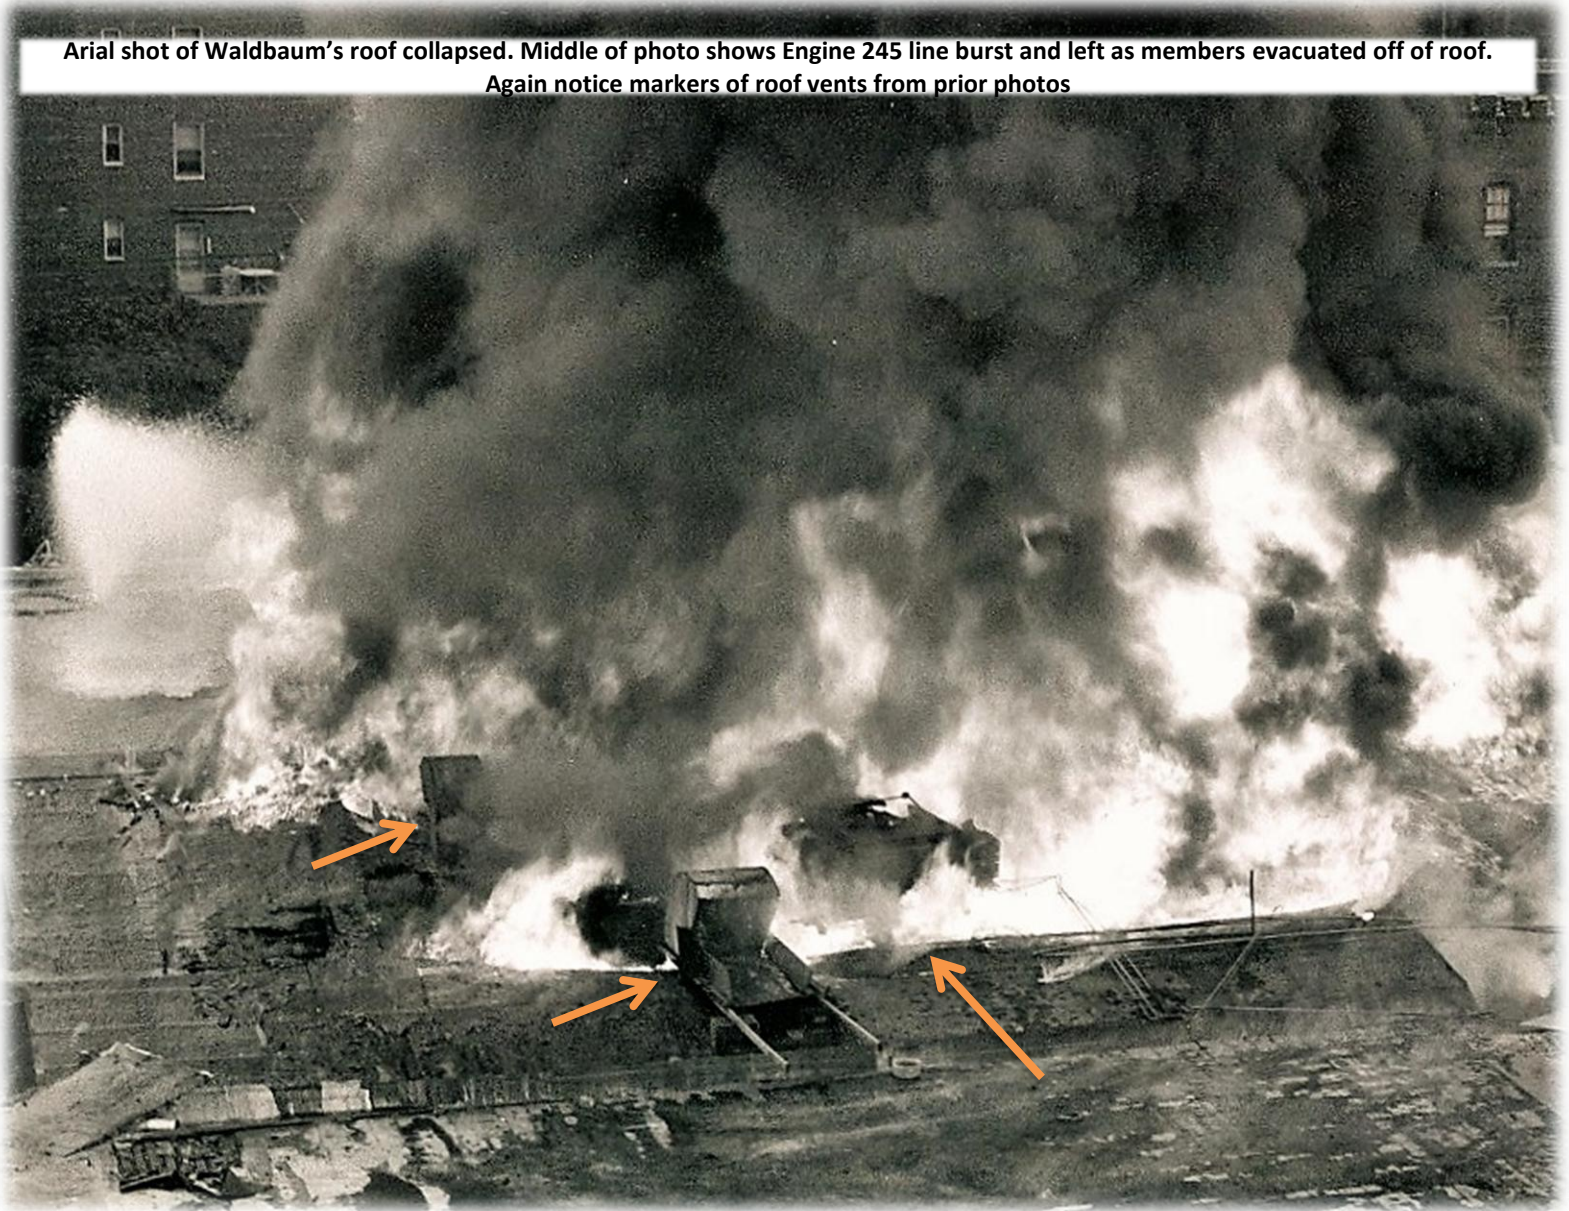
Arial shot of Waldbaum's roof collapsed. Middle of photo shows Engine 245 line burst and left as members evacuated off of roof.
Again notice markers of roof vents from prior photos
