NISTIR 6030

**THIRTEENTH MEETING OF THE UJNR
PANEL ON FIRE RESEARCH AND SAFETY,
MARCH 13-20, 1996**

FIRE INVESTIGATION
An Analysis of the Waldbaum Fire, Brooklyn, NY
August 3, 1978

J.G. Quintiere
University of Maryland
College Park, MD 20742

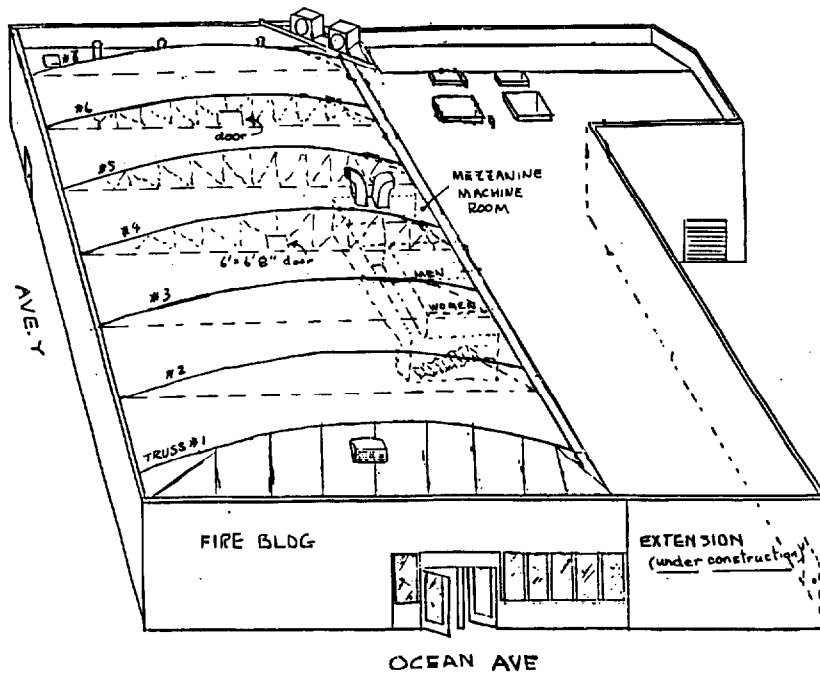
On August 3, 1978 a fire occurred at the Waldbaum supermarket in Brooklyn, NY. A sketch of the store is shown in Figure 1. At the time of the fire, an extension was under construction as indicated. The store was a typical supermarket with a mezzanine along a portion of the north wall. The loft was completely of wood construction comprising the floor, roof,

Figure 1. Overview of store with the extension under construction.

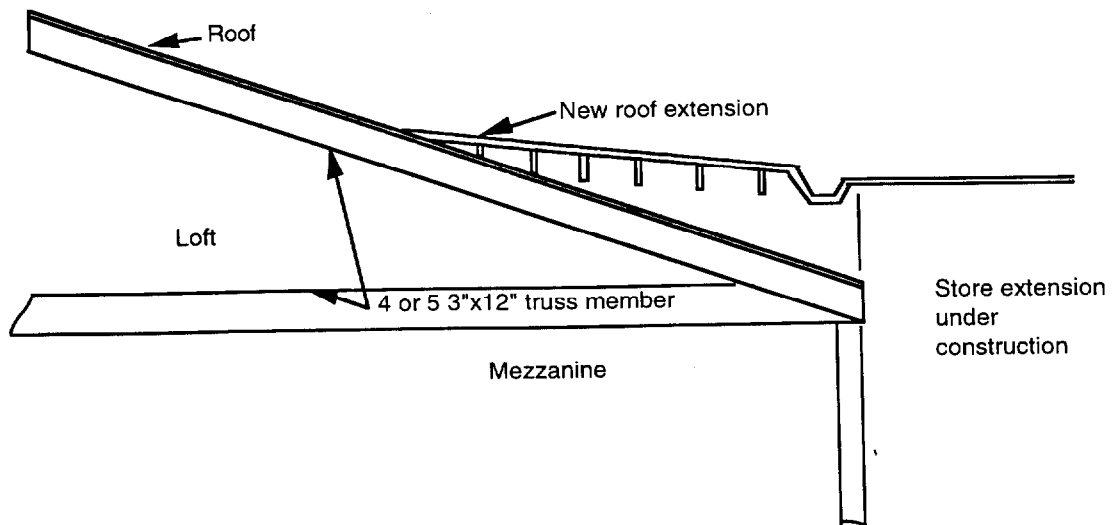
Figure 2. Splayed roof extension.

I was asked to assist William J. Petretis, Special Agent, of the Bureau of Alcohol, Tobacco and Firearms in the investigation of this fire 16 years after it occurred. Agent Petretis discovered the splayed roof extension shown in Figure 2, and reasoned the fire had to begin in that space. We then examined the hypothesis of the fire beginning there at approximately 6 a. m. to see if it could be consistent with later known events. A fire scenario was developed and calculations were examined to support the plausibility of the events and their duration. All of this

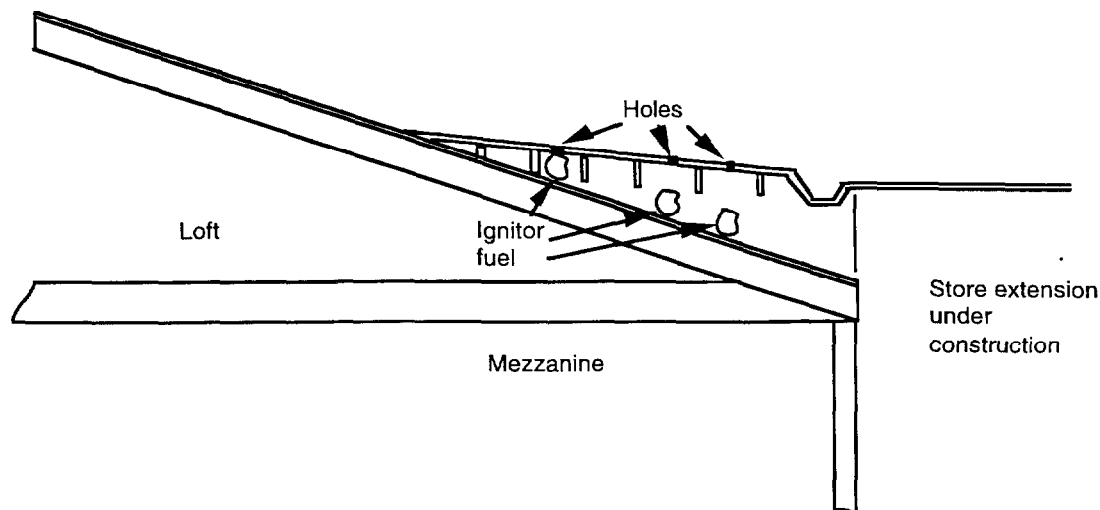
Figure 3. Flammable liquids soaked newspapers inserted into roof holes.

At approximately 6 a. m., an intentional fire is considered to have been set in the roof area adjacent to the construction of the building extension (Fig. 3). The fire is set by stuffing paper through holes in the new roof extension along with a liquid accelerant. The splayed roof extension has been built over the existing roof and forms a void space between the two roofs. The new roof is supported by rafters. The fire is set in channels of the wood rafters which extend between the primary wood trusses 4 and 5. Gaps under the rafters allow air to flow into the fire, but the space is mainly enclosed with temporary partitions at the wall adjacent to the new building extension. The accelerant soaked paper probably caused a fire of 100 to 500 kW in one or more rafter channels, involving no more than 1 m² (Fig. 4).

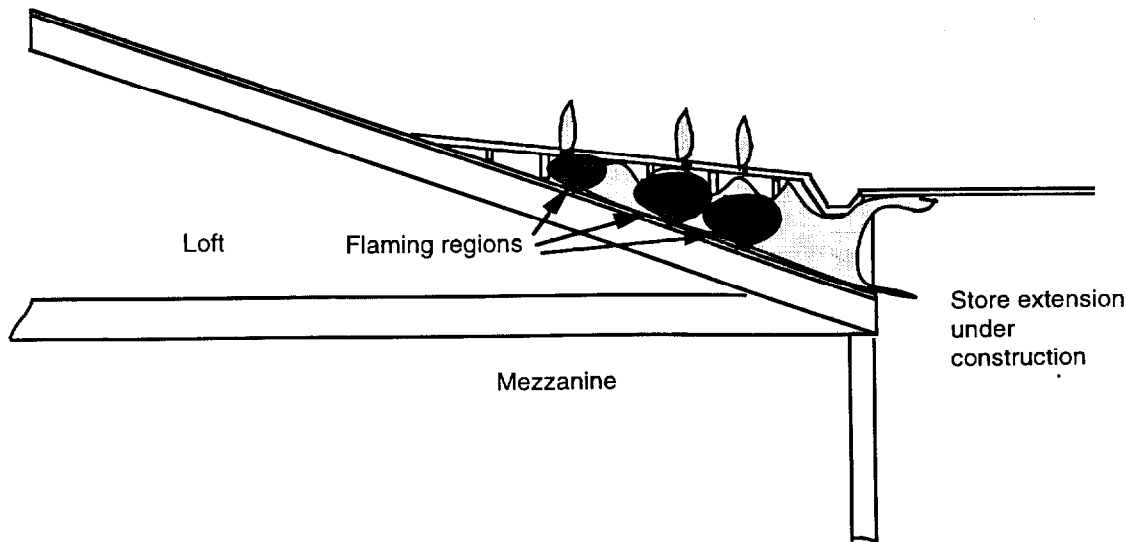
Under expected heat fluxes of 40 - 50 kW/m², the wood members would ignite in 30 seconds to one minute, and begin to contribute roughly 500 kW. The accelerant fire would probably burn-out in one to 2 minutes. The wood fire could progress to roughly 1000 kW, but then it would become limited in further growth due to combustion products filling this confined space.

Figure 4. Ignition at approximately 6 a. m.

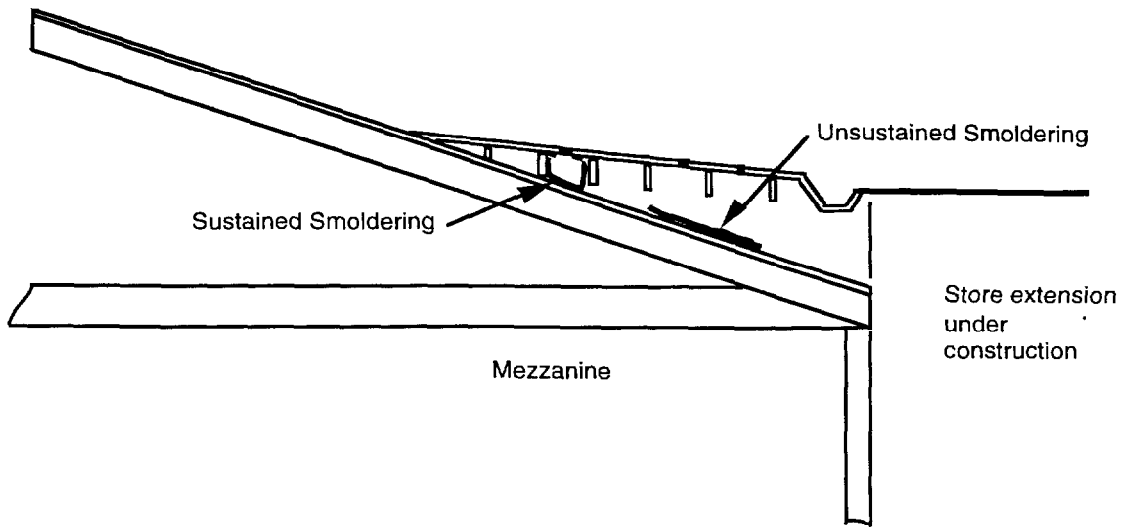
Oxygen depletion would cause flaming to cease in about 1-2 minutes following wood ignition. However, sustained smoldering would be possible, especially in the smaller rafter spaces where radiant heat transfer would be high. Ohlemiller (1991) reports that sufficient radiant heat transfer is necessary to sustain smoldering in wood cavities. He also reports smoldering propagation rates of 1 to 6 cm/hr. Using the smaller value, smoldering can propagate through the old 3/4 inch plank roof in roughly 2 hours. Hence, a short time before 8:30, a hole would form between the loft and the roof cavity. With air velocity increased to 25 cm/s Ohlemiller (1991) found the smoldering wood would change to flaming combustion. Such velocities would be realized at the hole as air was naturally induced to flow from the loft into the hole. Hence flames would erupt in the false roof cavity space.

Figure 5. Smoldering combustion at approximately, 6:05 a. m.

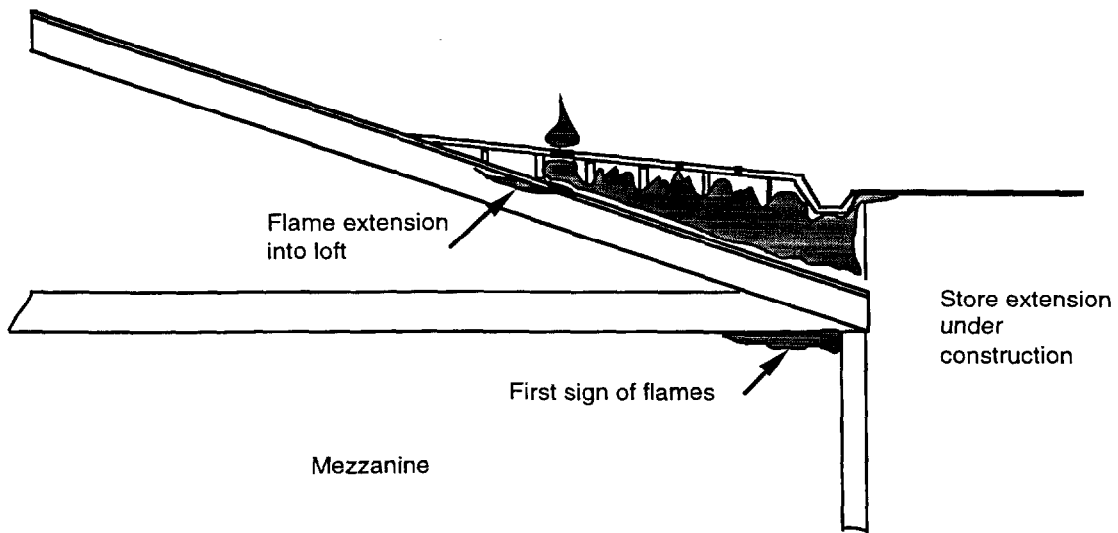
At approximately 8:30 am flames are observed in the mezzanine area at the wall and ceiling near truss 4. It is believed that this is due to the expansion of the flames as flashover caused a rapid rise in energy release

Figure 6. Flaming erupts in the roof cavity space shortly before 8:30 a.m.

rate in this confined space (Figure 6). The associated pressure increase forced flames through available void spaces. As the hole to the loft became larger, the increased air flow rate would also promote a larger flaming fire in the rafter spaces. The flow of the flaming combustion products would follow the rafter channel to the end points at trusses 4 and 5. Hence, the first flames are seen at an opening near truss 4. As the hole to the loft became even larger, flames would lap upward under the sloping wood ceiling of the loft. The person in the loft before this time would not have been aware of the fire since smoke would not permeate into the loft until the hole became large. In fact, he only saw flames when he descended to the machine room after being warned of the fire.

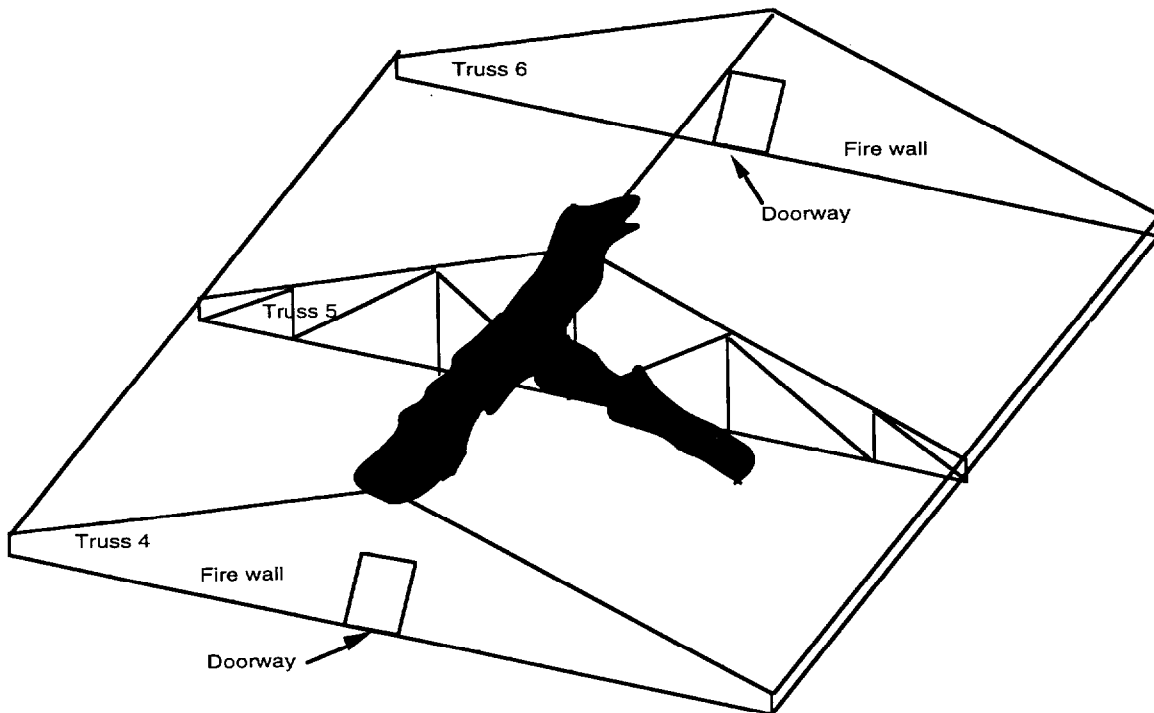
Flame spread would rapidly move from the hole, up and under the loft wood ceiling. It is estimated that flames would move from the hole region up and along the peak of the loft to truss 4 and through truss 5 in 2-3 minutes. This time was estimated from a flame spread model (Quintiere, 1994) using an ignition time of 30 s, and an energy release rate per unit area of 150 kW/m². This rapid spread (Figure 8) seemed incredulous; and, with the low confidence in flame spread calculations, an experiment was performed in a similar, but smaller loft. Flashover occurred in the experiment in approximately 1 minute. In the store loft, flashover was estimated to occur when the wood contribution is 6 to 12 MW in the section of the loft between trusses 4 and 6. The flame spread calculation indicated that this would occur in approximately 2 1/2 minutes. Full involvement was estimated to take up to 5 minutes more. Hence, from the onset of flaming at the hole, full involvement of the loft

Figure 8. Fire growth in the loft at approximately 8:35 a. m.

section would take approximately 5 to 10 minutes. Because of the false roof sections and the truss fire-wall sections, the firefighters on the roof were unaware of the raging fire in the loft section below them.
