DIVISION 7 TRAINING AND SAFETY NEWSLETTER

August 2016

38TH ANNIVERSARY OF "WALDBAUM'S"

"Waldbaum's."

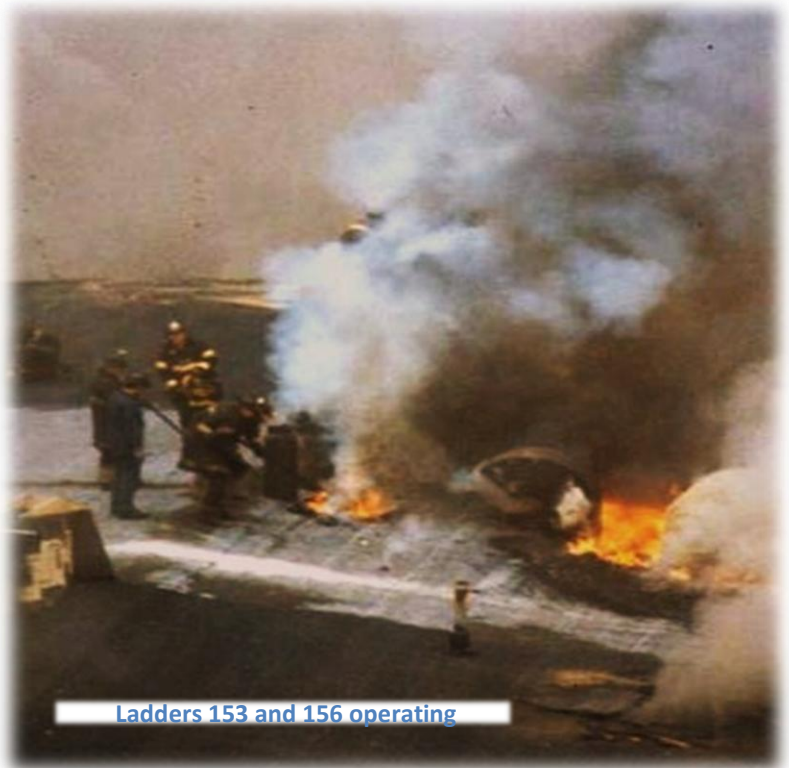
Engine 246 stretched a 2 ½ inch hand line to roof up Ladder 156 on Ocean Avenue, Exposure 1

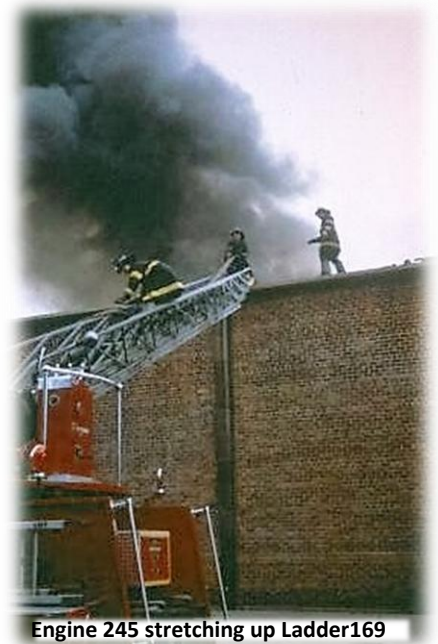
All members are now operating on roof. Engine 245 is operating. All six members of Ladders 153 and Ladder 156 are now operating between Truss 4 and 6 cutting roof. They are in the foreground. Battalion 42 and Rescue 2 can be seen behind them to the far left. Take notice of smoke condition 5-10 minutes before collapse. The arrow below is a land mark for position of units on roof.

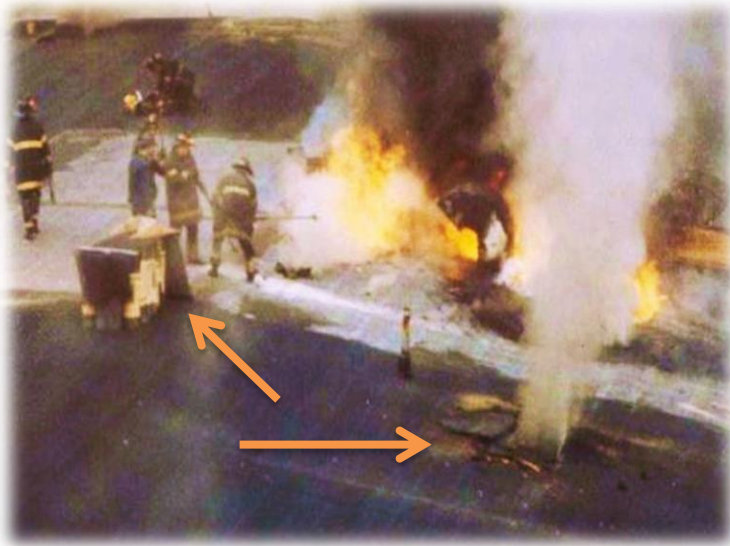
This is the last photo that captures 10 out of the 12 members moments before they fell through the roof. The far right of photo shows the start of the collapse.

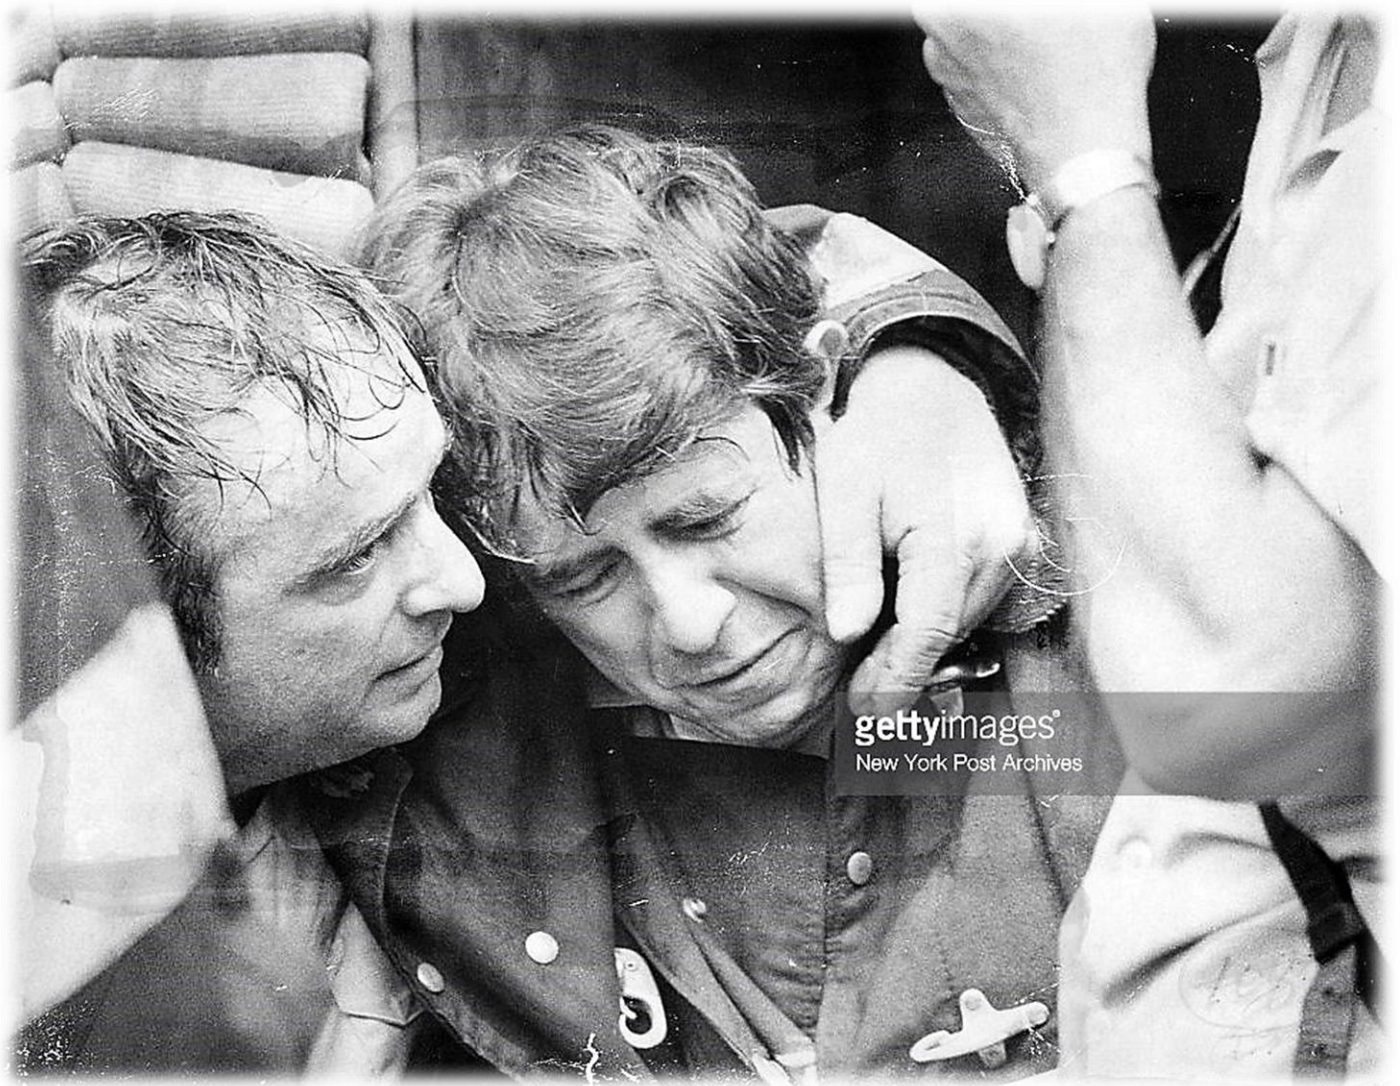
The two firemen above are unidentified in the New York Post photo but it captures the raw emotions of the loss and heartache the men felt that day.

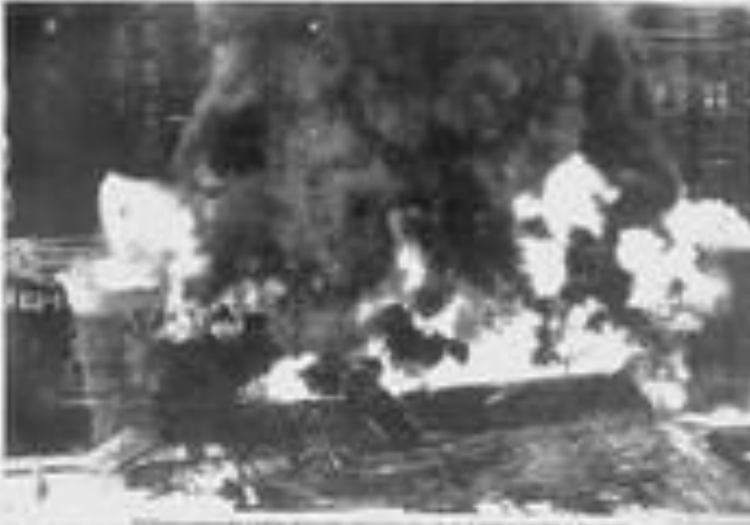
Roof Collapse Sends Six Firemen to Death in Sea of Flames

NEW YORK (AP) — Six firemen were killed and 11 others injured when a section of the roof of a five-story building collapsed into a sea of flames and smoke early Monday morning.

The fire department is currently investigating the cause of the collapse. It is believed that the roof was weakened by the fire and the weight of the debris.
